MDG 3002

Fatal accident Newstan Colliery 26 June 1991

## SYSTEM SAFETY ACCIDENT INVESTIGATION SUMMARY

FATAL ACCIDENT NEWSTAN COLLIERY 26 JUNE 1991

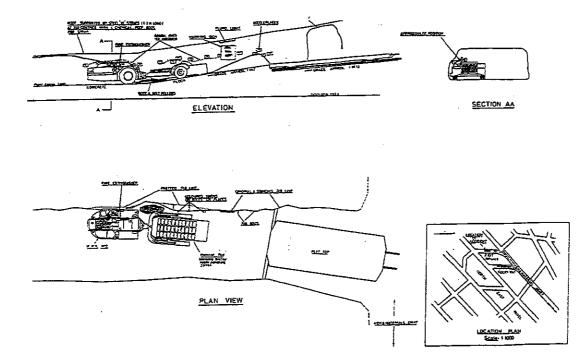
On Wednesday, 26 June, 1991, at approximately 3.50 pm. in an angled material shunt at the bottom of the men & material drift, Young Wallsend seam, Newstan colliery, a machineman sustained fatal injuries when crushed between the rib and the steering wheel of a dual drive Mark I MPV. The victim was apparently moving the MPV forward off the ramp while seated in the driving seat that faced opposite the direction of travel of the vehicle. The rib had been undercut over time. This allowed the driver's compartment to enter the undercut, and resulted in trapping the driver.

The diagram below shows the layout of the accident scene.
