**Fatal accident Metropolitan
Colliery, 2 April 1992**

**SYSTEM SAFETY ACCIDENT INVESTIGATION
SUMMARY**

**FATAL ACCIDENT
METROPOLITAN COLLIERY
2 APRIL 1992**

SSAI SUMMARY No. 4

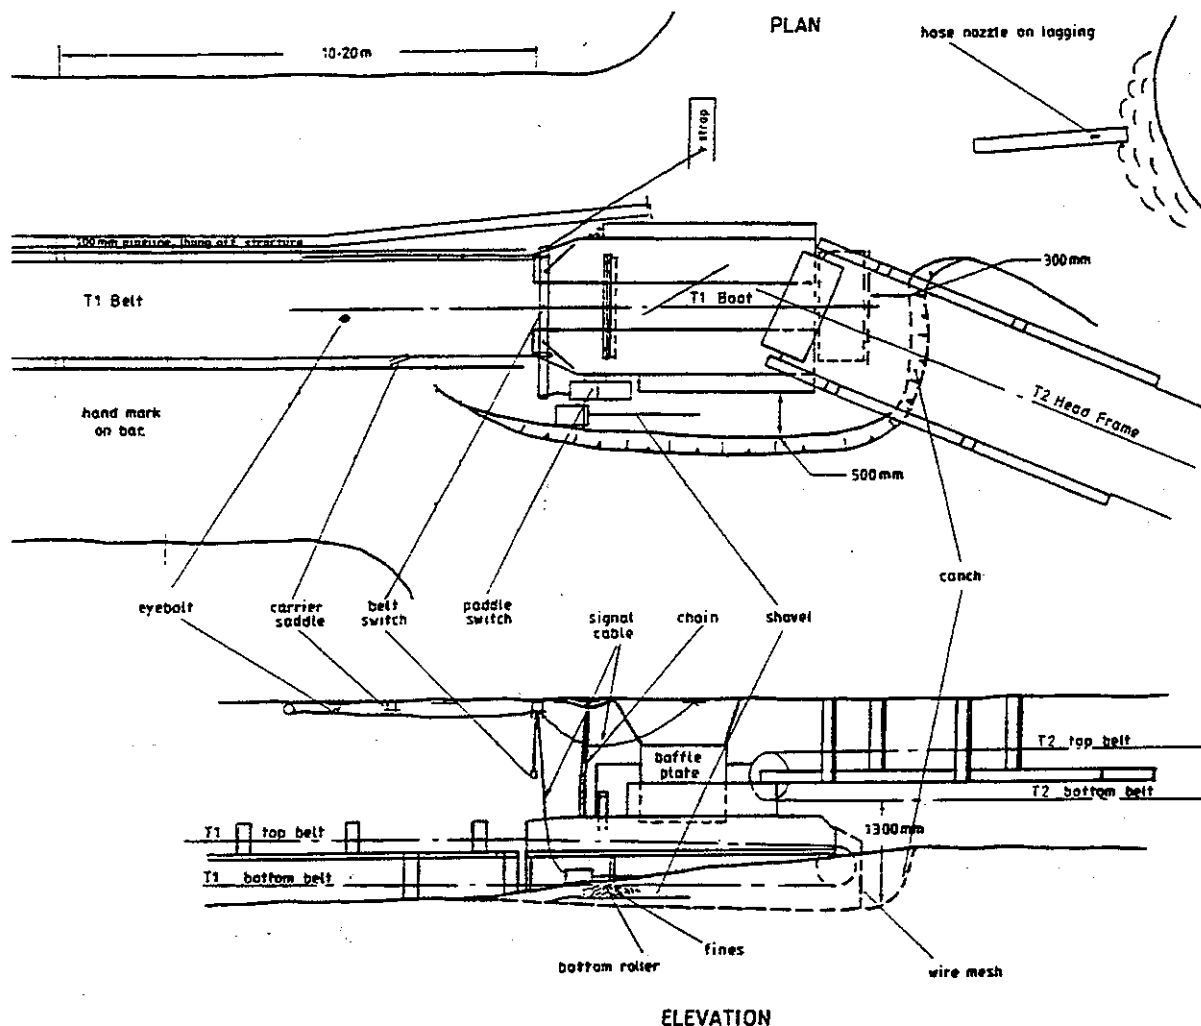
The workman's body was discovered on the bottom belt of T1 trapped by his right ankle under a hold down roller approximately 600 metres outbye of his allocated belt cleaning duty area. Evidence indicated that he had been carrying out belt cleaning duties at the belt transfer point, shown below.

It appeared that the workman was transported on the top side of the T1 belt from a location adjacent to the inbye transfer point feeding the belt. It was not determined how he was dislodged from the top belt to the bottom belt at place of discovery.

It was also not possible to fully determine how the workman came to be on the conveyor belt. Inspection of the area found that access was available to both sides of the transfer point via the rear of the boot-end pulley. A belt isolation switch was also located in this area albeit there was no prestart warning signalling system installed.
