MDG 3002

Fatal Accident Gretley Colliery

**SYSTEM SAFETY ACCIDENT INVESTIGATION
SUMMARY**

**FATAL ACCIDENT
GRETLEY COLLIERY
14 November 1991**

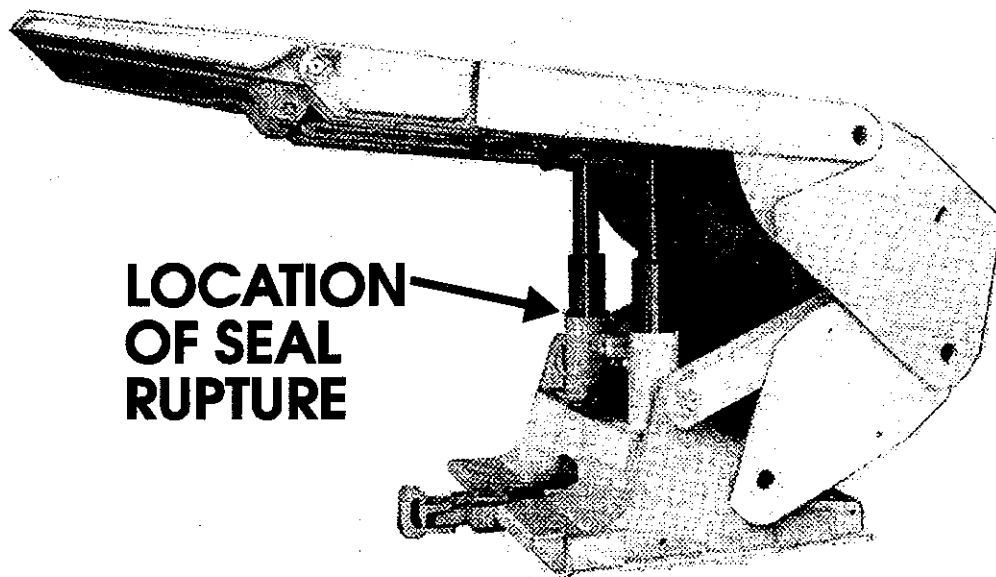
The steel plug on the main stage power down port had apparently been inadvertently left in place and the leg only hosed up to the extent of connecting a hose to the power up port. When operating hydraulic pressure, (5,000 psi) was applied to the bottom of the cylinder to raise the leg to the canopy, fluid on the opposite side of the main stage piston was unable to escape. Intensification of pressure occurred in the main stage power down annulus which resulted in leg dilation and the rupture of the seal at the gland in the top of the cylinder barrel.

The location of the seal rupture and emission of hydraulic fluid under high pressure is shown overleaf.

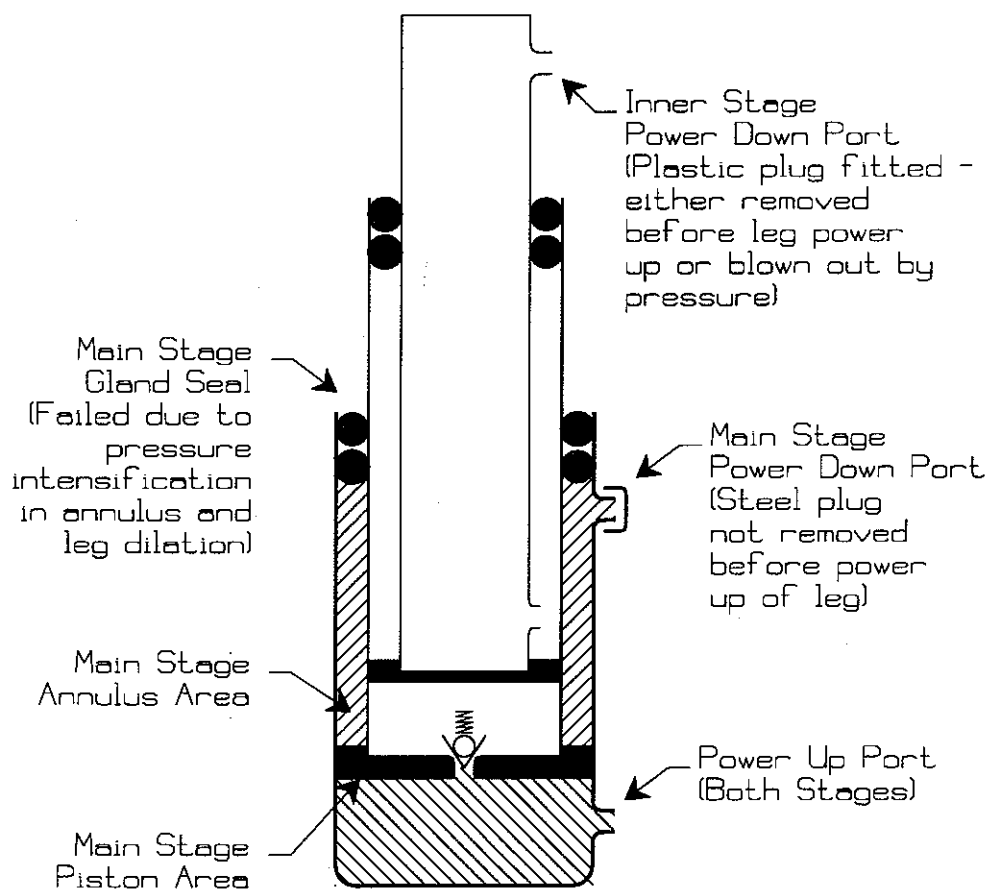
The area ratio of the main stage piston to main stage power down annulus was such as to create a pressure of up to 60,000 psi within the annulus. A schematic of the type of dual extension, double acting hydraulic roof support leg involved is shown below.
